Manhole Inspection Summary

Manhole # S29S__012MH

Insp Date: **10/31/08 7:50 AM**

Location Address: **1600 Ridgley St**

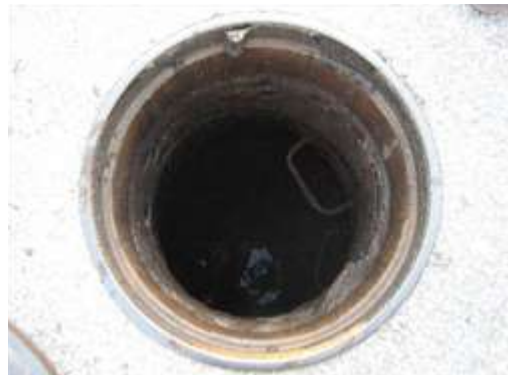
frame view

Frame Leaks

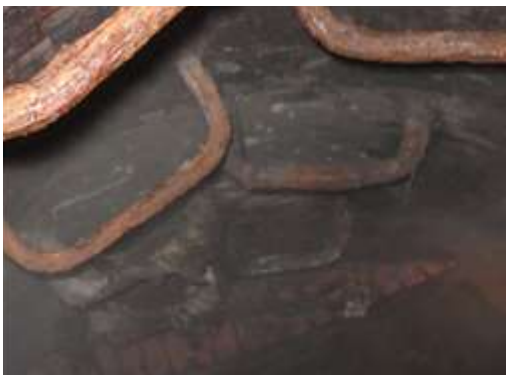
Defect 3

☒ **Evidence Of Surcharge** Depth: **7** (ft.) ☐ Active Surcharge Present

surcharge evidence

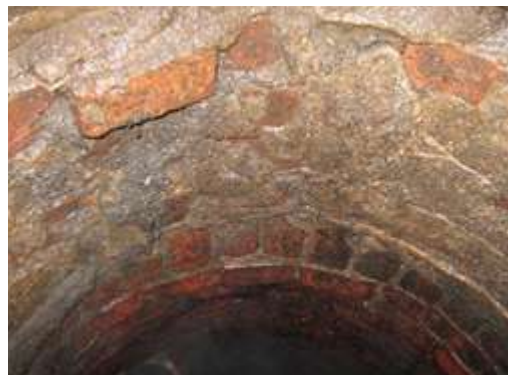
Defect 2

Condition: ☐ Sound ☐ Cracked ☐ Root Intrusion ☒ **Loose Brick** ☒ **Deteriorated**

Condition: ☐ Sound ☐ Cracked ☐ Root Intrusion ☐ Loose Brick ☒ **Deteriorated**

deteriated chimney/ corbel, loose brick

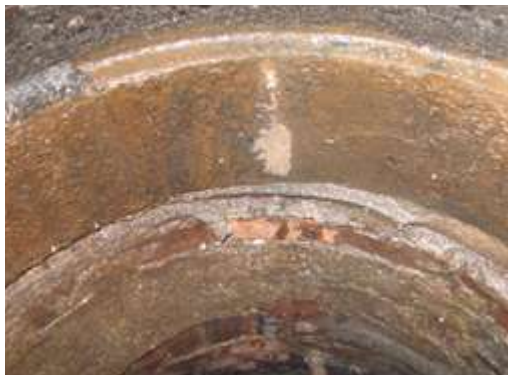
Defect 1

Condition: ☐ Sound ☐ Cracked ☒ **Leaks**

lid/frame infiltration..deteriated chimney

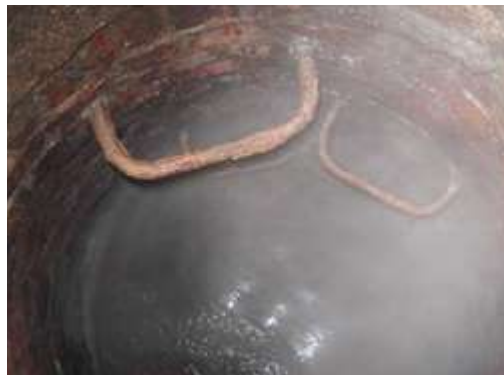
Count: **7** Missing: **0** ☒ **Corroded**

oxidized rungs/ corroded

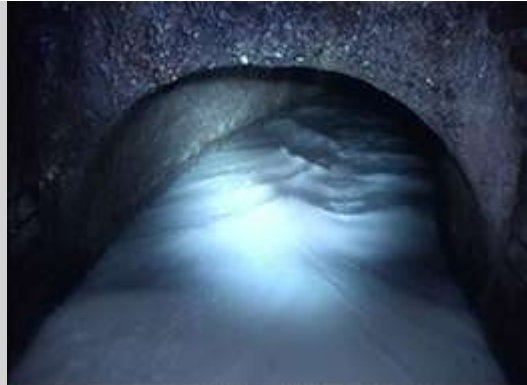
12 O'Clock Outflow

39 in. Circular Gravity Sewer
Pipe Out @ 12OClock

Pipe Height: **36** (in.) Rod and Bar (Angled)
Pipe Material: **Clay** ☐ Pipe Lined
Invert Depth: **14.60** (ft.) Flow Characteristics: **None**
Deposits: ☒ None ☐ Mud ☐ Sludge ☐ Debris ☐ Grease
Silt Depth: **0** (in.) Deposits Extent:
Infiltration: **None** Pipe Seal Cond: **Sound**

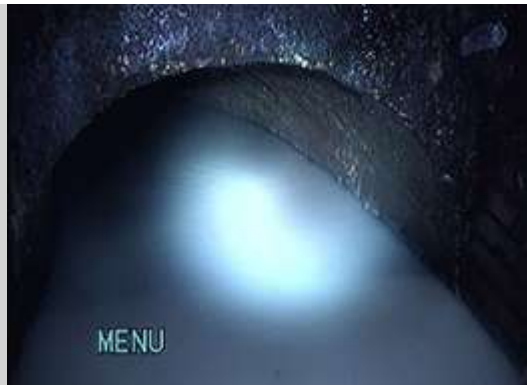
6 O'Clock Inflow

39 in. Circular Gravity Sewer
Pipe IN @ 6 OClock

Pipe Height: **36** (in.) Rod and Bar (Angled)
Pipe Material: **Clay** ☐ Pipe Lined
Invert Depth: **14.49** (ft.) Flow Characteristics: **None**
Deposits: ☒ None ☐ Mud ☐ Sludge ☐ Debris ☐ Grease
Silt Depth: **0** (in.) Deposits Extent:
Infiltration: **None** Pipe Seal Cond: **Sound**

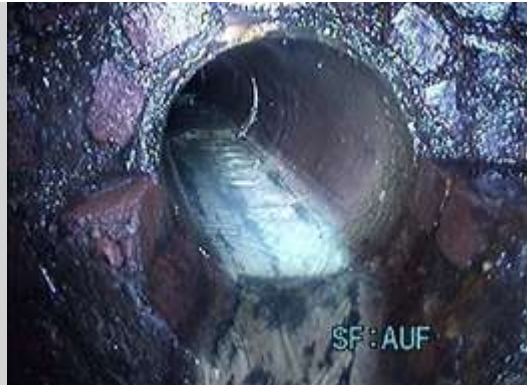
8 O'Clock Inflow

8 in. Circular Gravity Sewer

Pipe IN @ 8 O'Clock

Infiltration: **None**

Pipe Seal Cond: **Sound**

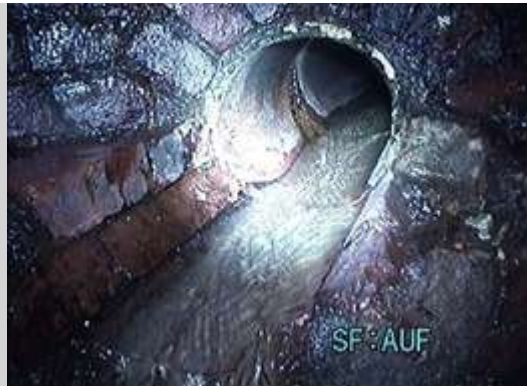
10 O'Clock Inflow

8 in. Circular Gravity Sewer

Pipe IN @ 10 O'Clock

Infiltration: **None**

Pipe Seal Cond: **Sound**
